## **LIFE Peat Restore**

**LIFE project «Reduction of CO<sub>2</sub> emissions by restoring degraded peatlands in Northern European Lowland»**

# **State of the project site and consequences for project implementation**

## **ESTONIA**

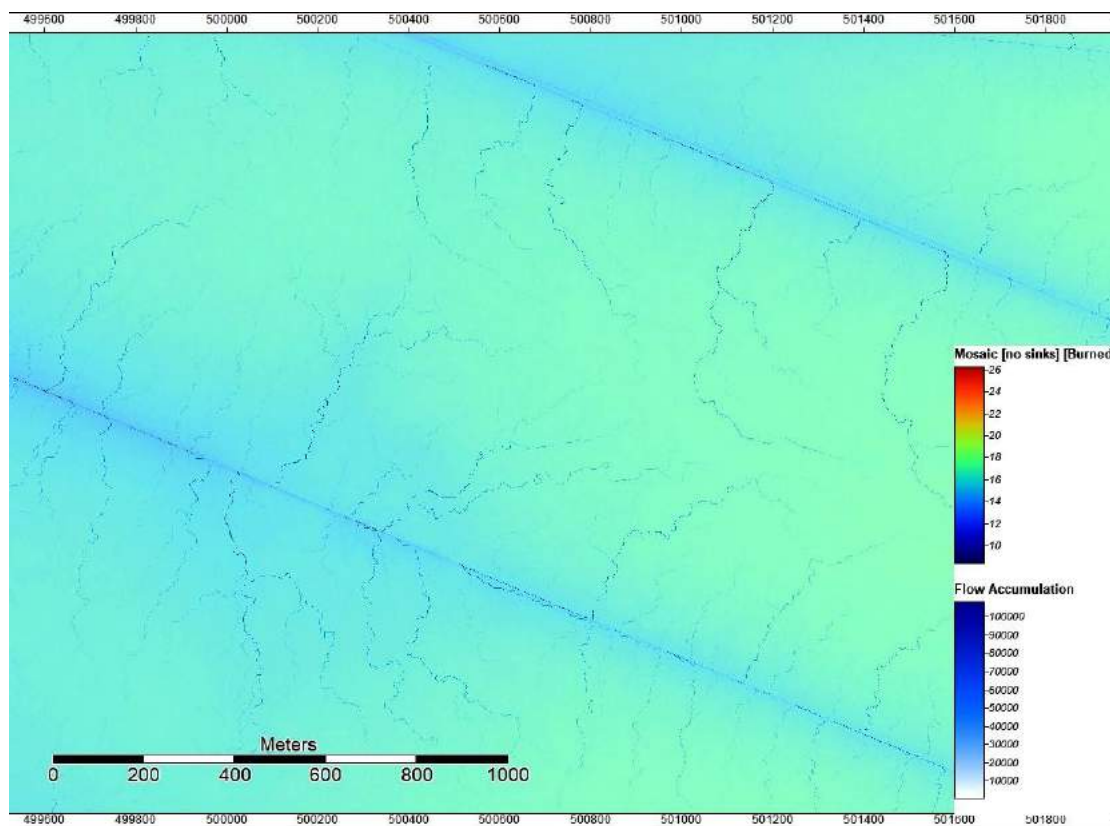
*Fig. 2. Example of the surface elevation and flow accumulation map (middle part of the restoration area). Surface slope and flow lines are aligned towards the large ditches.*

Results of the surface topography modelling (digital elevation model) indicate that ditches network has been changed importantly the surface topography as peat is compressed and mineralized and mire surface sunk importantly near the larger ditches. At the same time the *Sphagnum* growth and peat accumulation is going on watersheds away from the ditches. This changed local surface slopes, increased surface gradient and decreased flowline lengths. It means that runoff conditions are getting better for all parts of the restoration site. Historically the overall slope of the area was to the north-west towards the Vihterpalu River. At present, slope is towards the nearest larger ditch (Fig. 2) in most places. Maximum distance to the nearest ditch is ca 500 m but most of the areas located more close to the ditches. So the results indicate continuing negative impact of drainage and urgent need for restoration.

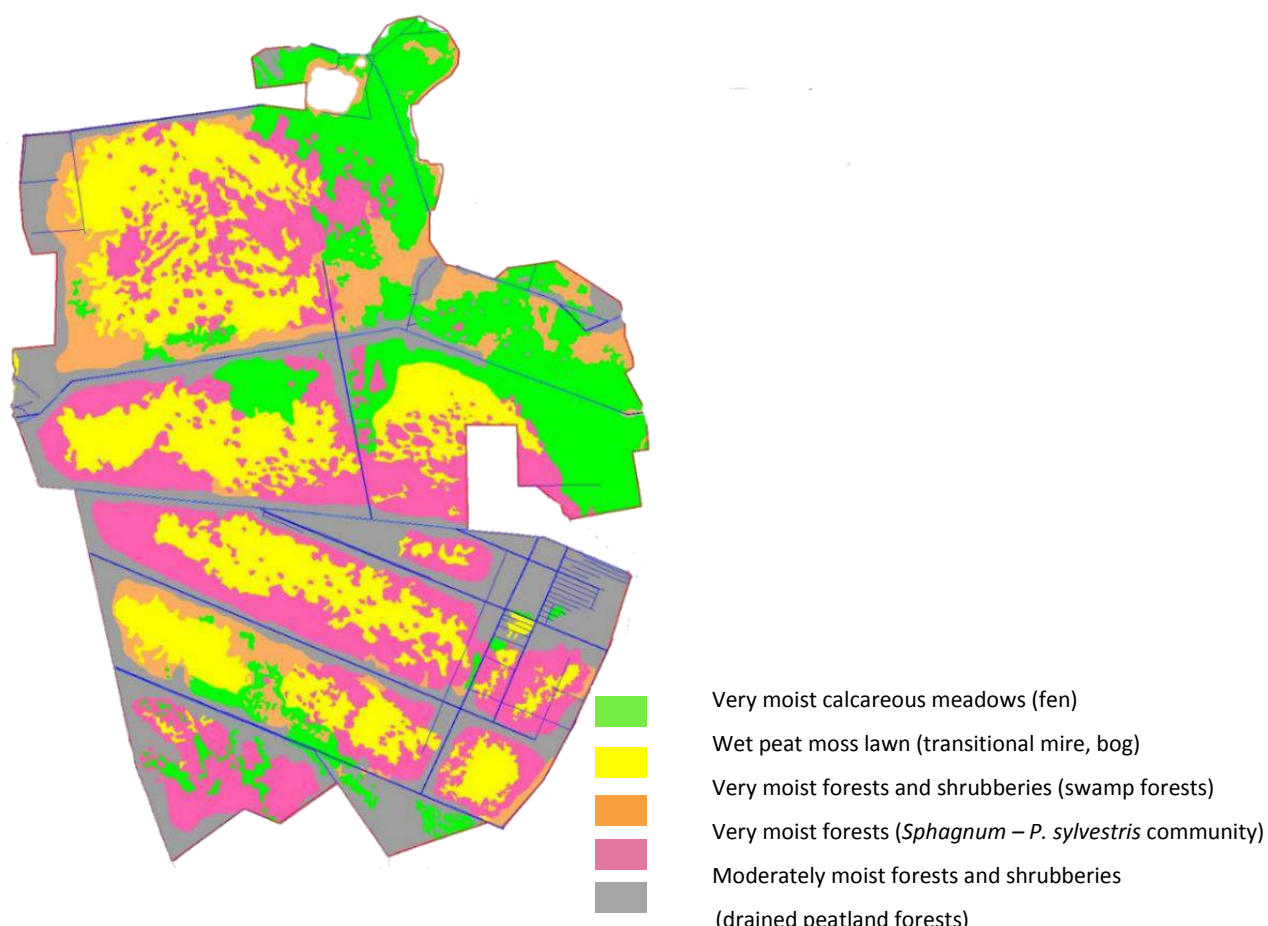
Fig 3. Distribution of the GEST types on the Suursoo-Leidisoo project site. Blue lines are ditches.

Distribution map of the GEST types indicate that more drained types located close to the ditches and more natural types located on the larger distance (at least 100-200 m) from ditches. Exception is Very moist calcareous meadows (fen) that is crossed by the larger ditches, which have not very strong impact. This is caused by small surface gradient and activity of beavers on these areas. Water level monitoring data indicated that character of vegetation and natural state of the GESR types is related strongly the strength of the drainage impact. Drained types have much deeper water levels and larger water levels amplitudes compared with more natural types (Table 1).

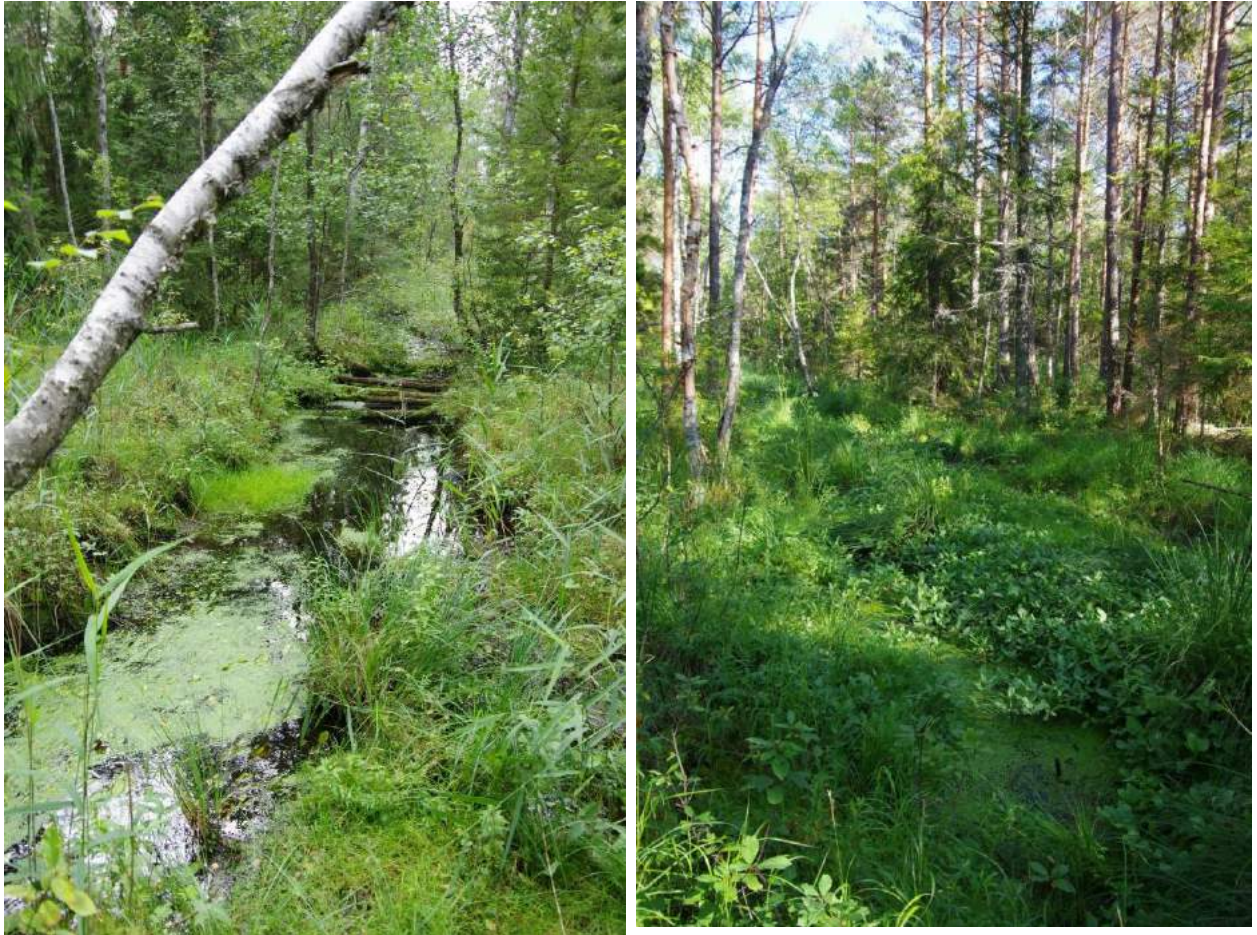
*Ditches in south-eastern part of the project site, surrounded by drained peatland forests (GEST Moderately moist forests and shrubberies) – previous open alkaline fens.*

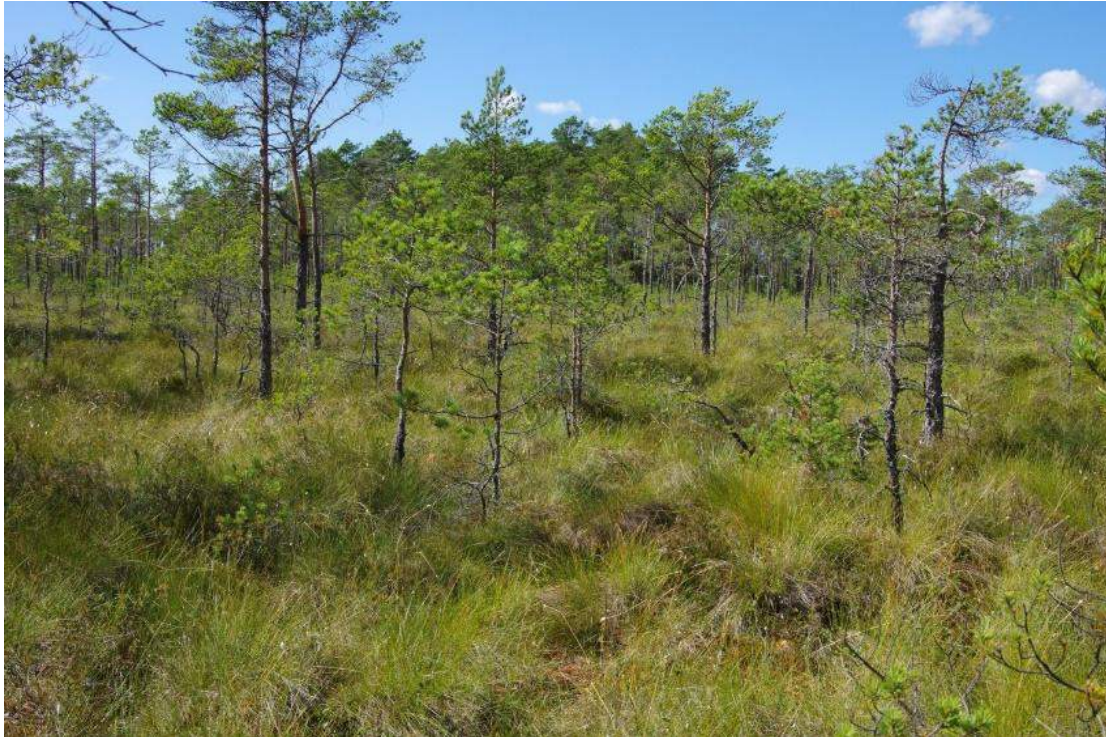
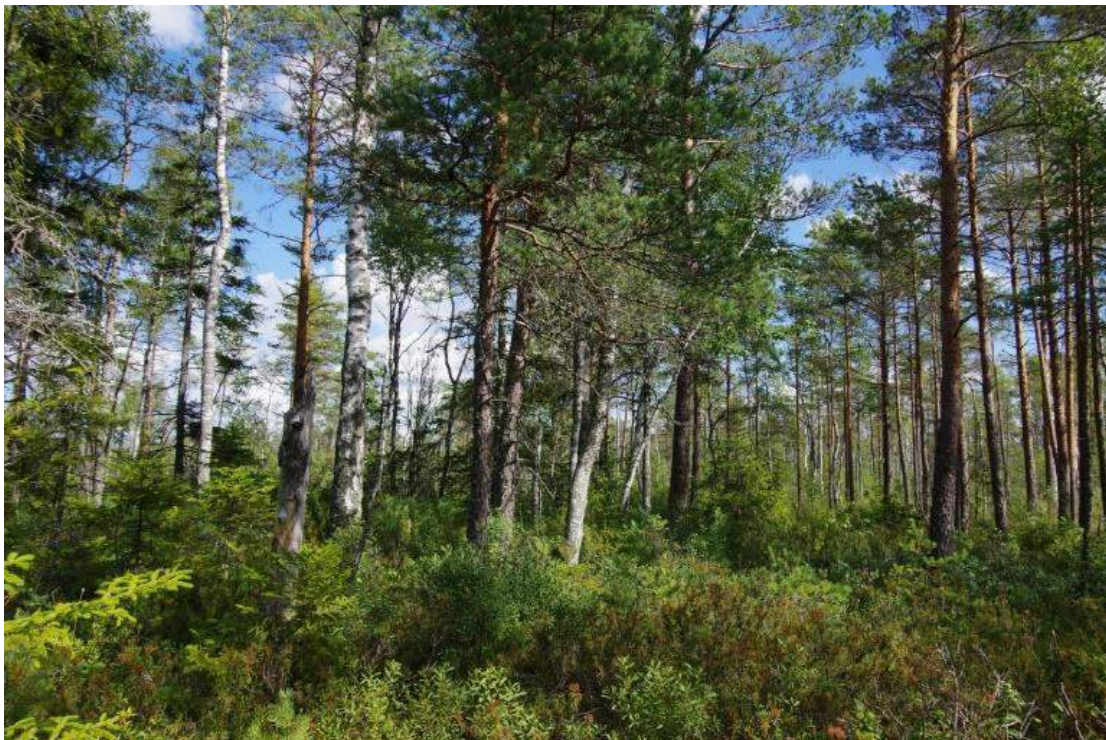
*Transitional mire (GEST Wet peat moss lawn) and mire forest (GEST Very moist forests: Sphagnum – P. sylvestris community) – previous open alkaline fens.*

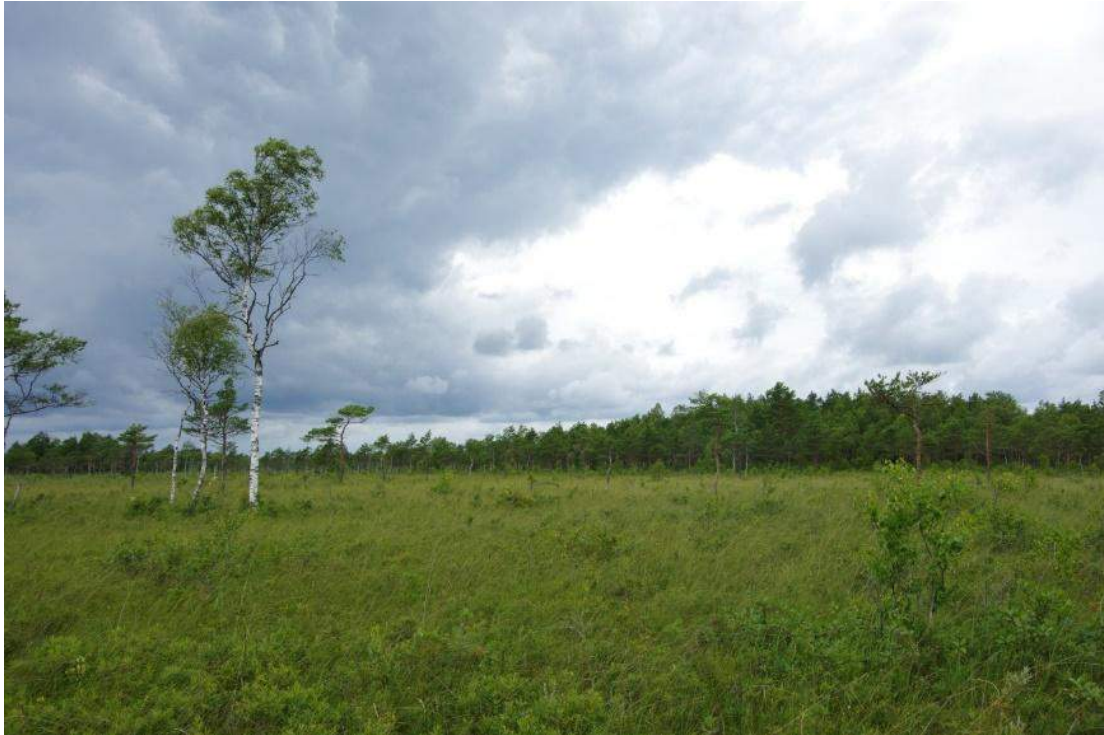
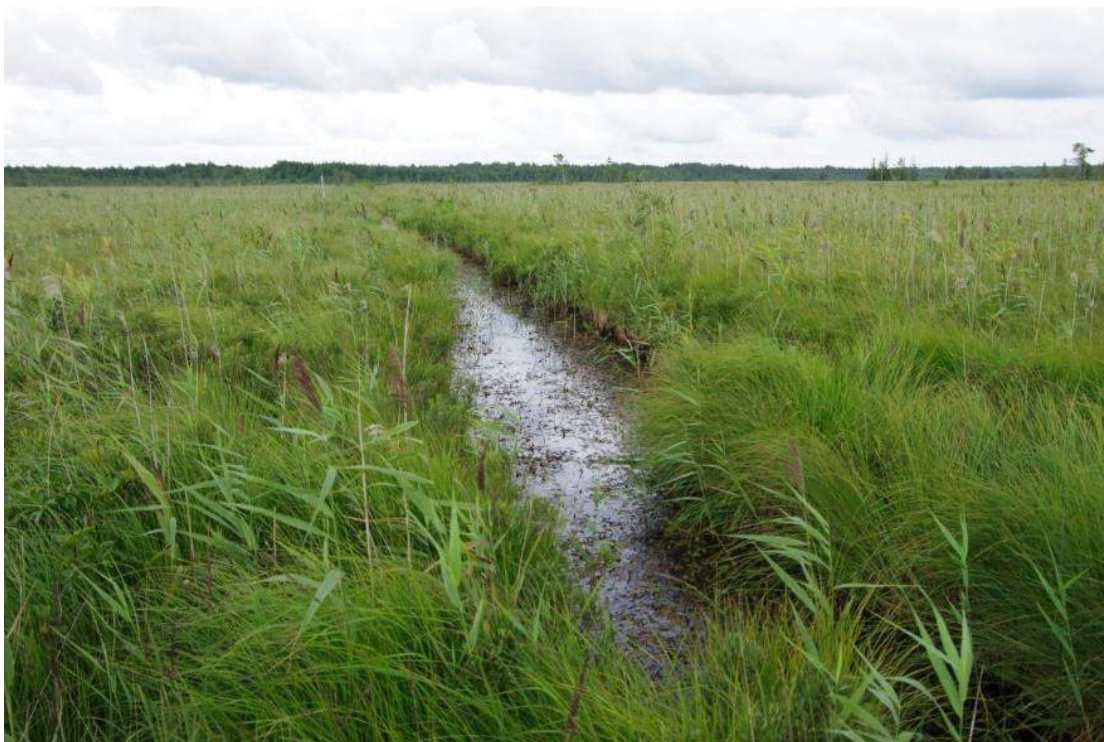
*Still preserved alkaline fens (GEST Very moist calcareous meadows) and crossing ditch Pennu stream in eastern part of the project site.*

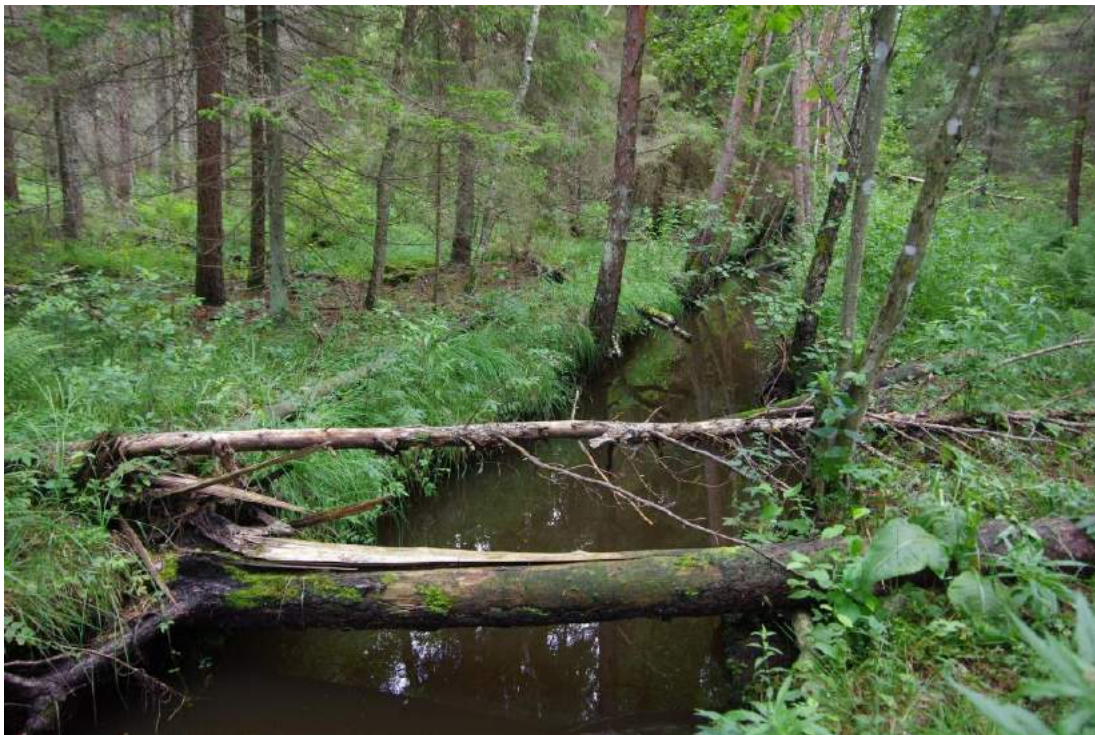
*Kaldamäe stream on the middle part of the project site (2.3 km downstream) surrounded by drained peatland forests.*
