## **LIFE Peat Restore**

**LIFE project «Reduction of CO<sub>2</sub> emissions by restoring degraded peatlands in Northern European Lowland»**

# **State of the project site and consequences for project implementation**

## **ESTONIA**

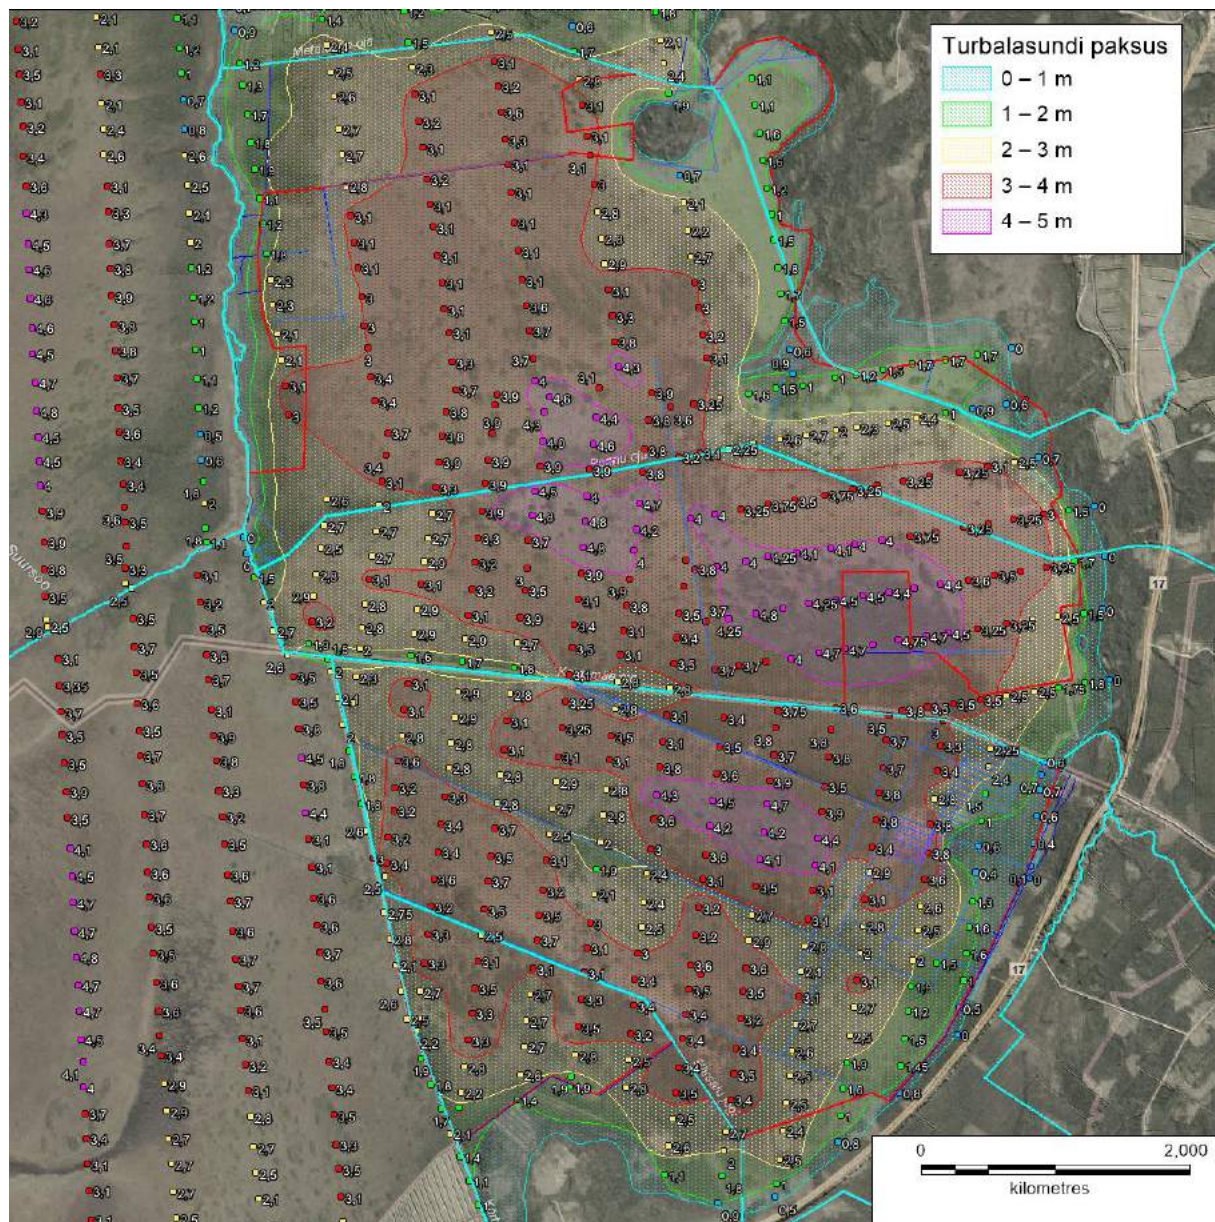
Fig. 2. Map of peat depth on the Suursoo-Leidissoo project site (based on measurements of the Estonian Geological Survey, 1981).

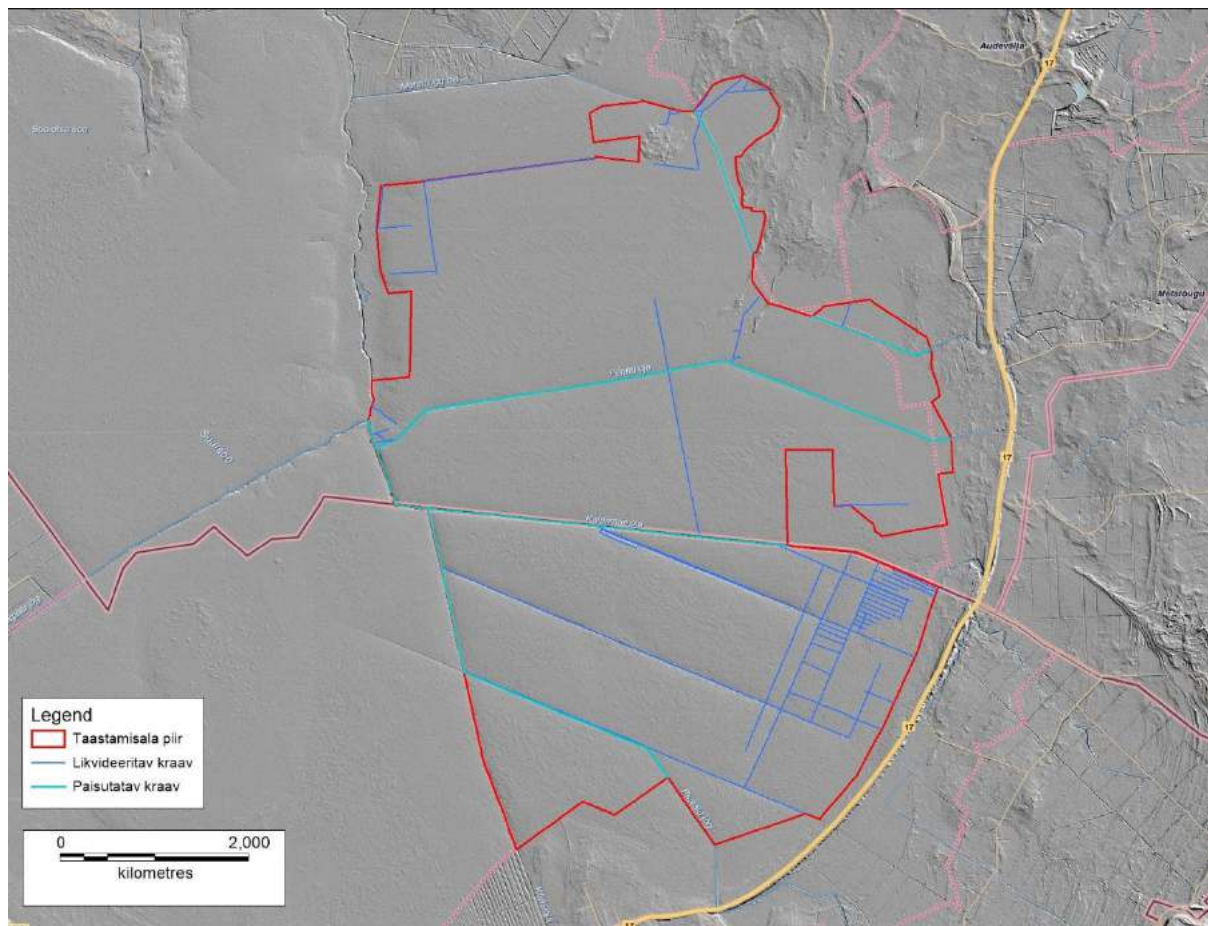
Fig. 4 Restoration site on the relief map of the Estonian Landboard with ditches that are planned to fill (blue lines) or dam (electric??? Lines). (Maa-ameti WMS-teenus)

Pennu, Kaldamäe and Metslõugu streams and the Piirsalu River will be dammed up to the level that does not influence the water table depth on areas out of the restoration site. Vihterpalu River and Kõrtsioja stream will not be influenced by restoration actions on the restoration site.

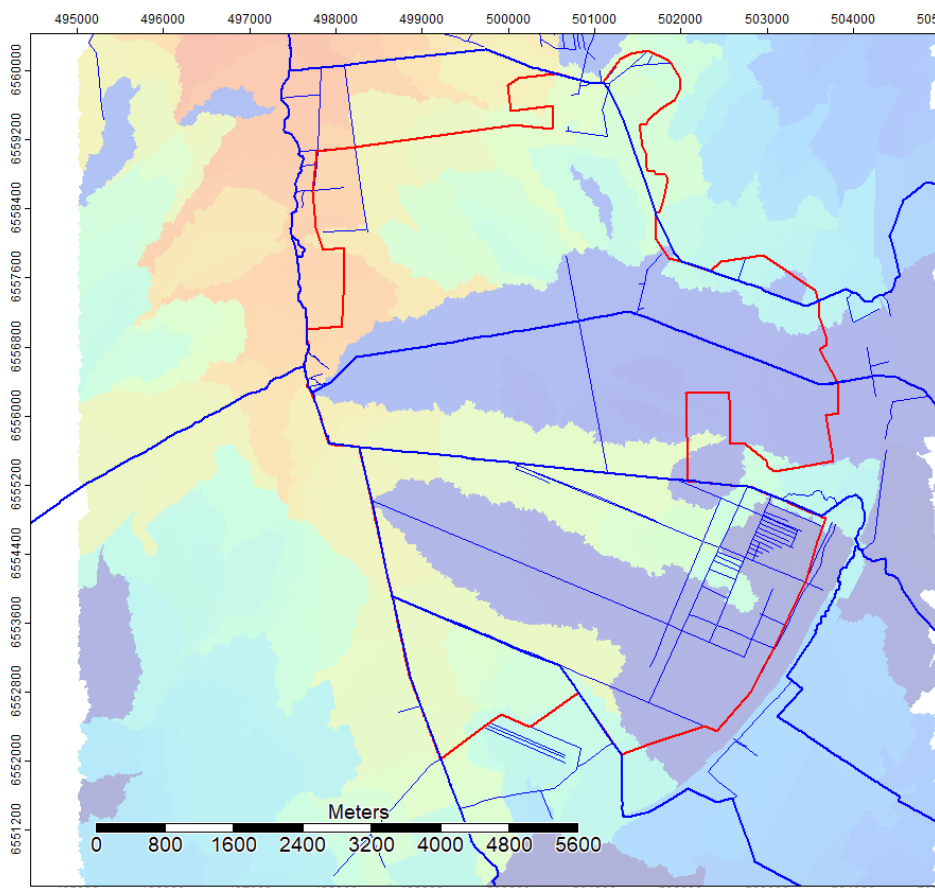
*Fig 5. Hydrological basins on Suursoo-Leidisoo restoration site. Constructed by SAGA GIS software using Estonian Land Board Elevation map.*

Overall conclusion of the monitoring and modelling data is that damming height should be as high as possible for the most ditches to maximize area of the positive impact of the water level raise. In several places is need for the dams with wider “wings” to raise water outside the surface depression zone close the ditches. Exception is better preserved fen sites where it is enough to raise water up to the ditch banks and fen surface.

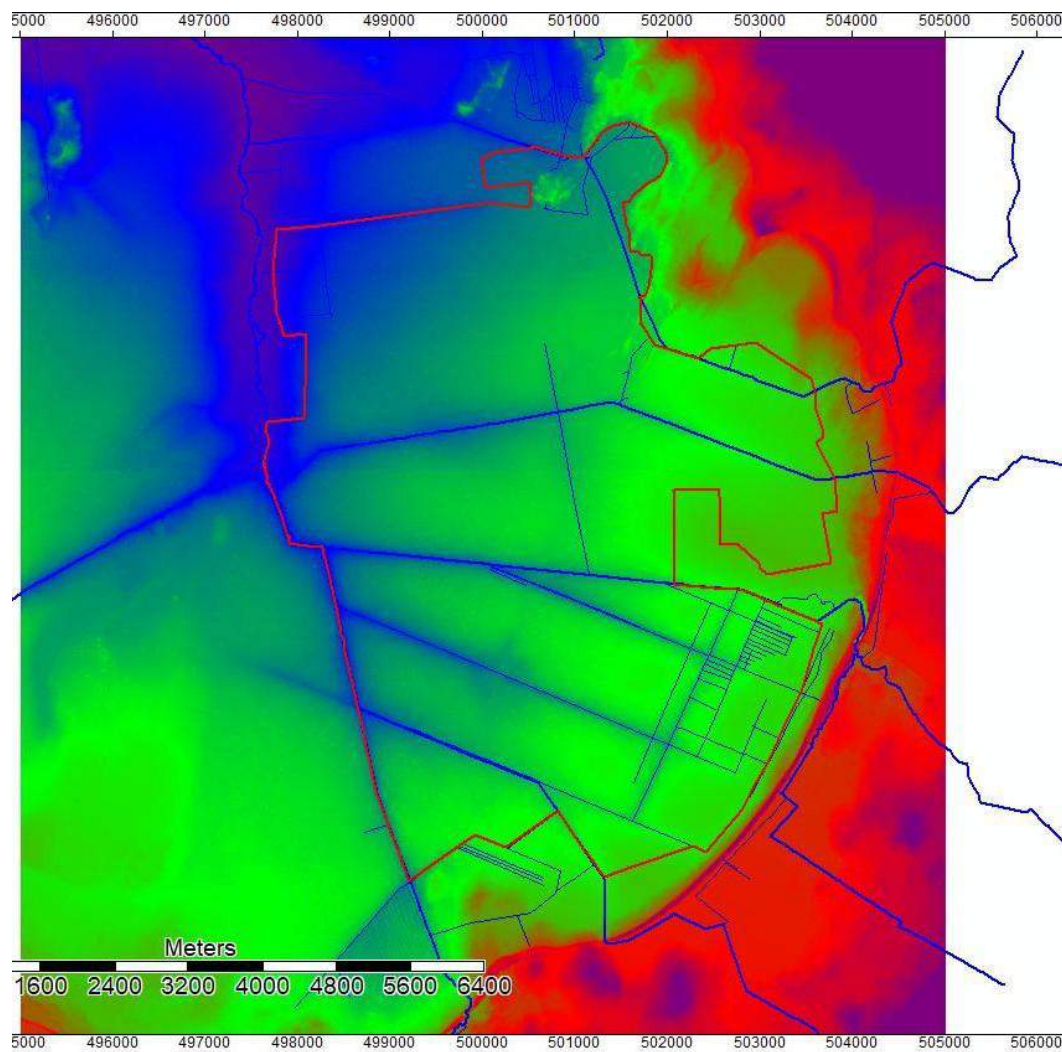
Results of the surface topography modelling (digital elevation model) indicate that ditches network has been changed importantly the surface topography as peat is compressed and mineralized and mire surface sunk importantly near the larger ditches. At the same time the *Sphagnum* growth and peat accumulation is going on watersheds away from the ditches. This changed local surface slopes, increased surface gradient and decreased flowline lengths. It means that runoff conditions are getting better for all parts of the restoration site. Historically the overall slope of the area was to the north-west towards the Vihterpalu River. At present, slope is towards the nearest larger ditch (Fig. 2) in most places. Maximum distance to the nearest ditch is ca 500 m but most of the areas located more close to the ditches. So the results indicate continuing negative impact of drainage and urgent need for restoration.

Fig. 6. Digital elevation model based on Lidar data – before damming of ditches.

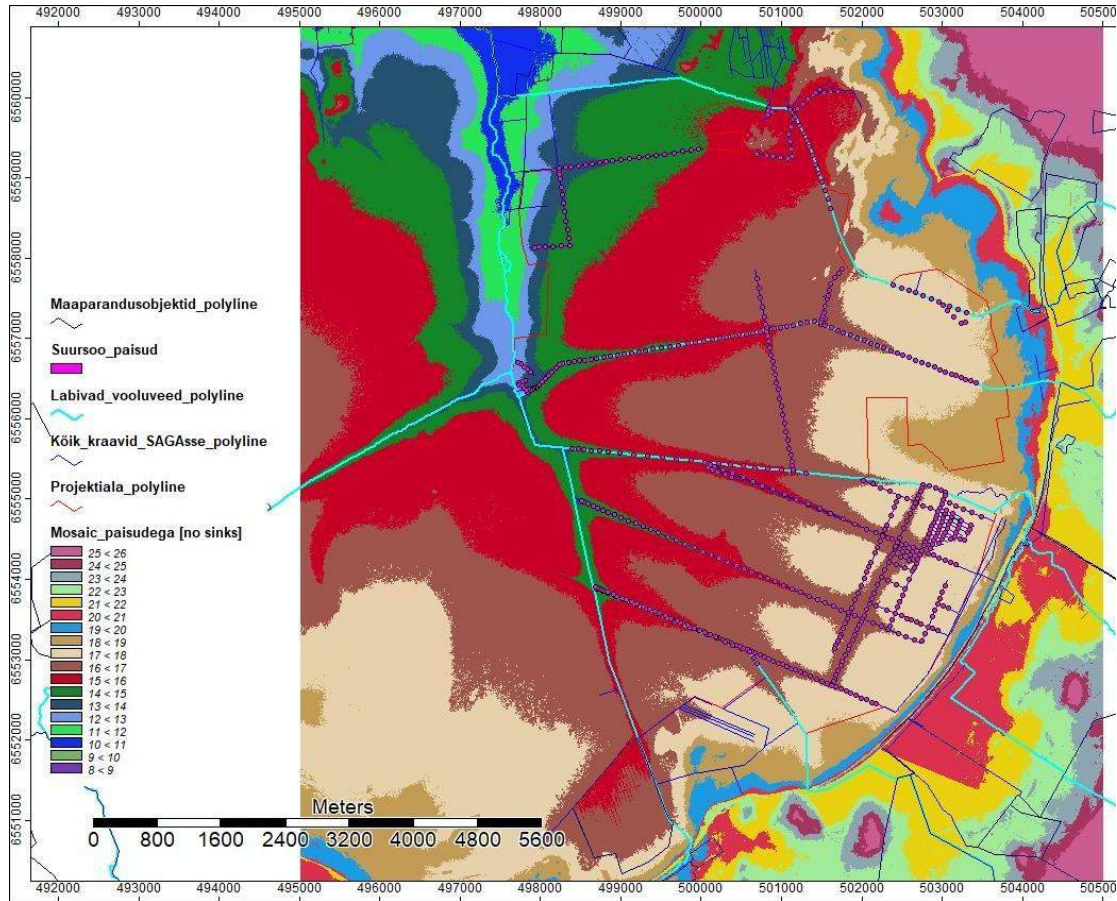
Fig. 7. Digital elevation model based on Lidar data – after damming of ditches. Dots on streams are expected sites for dams.

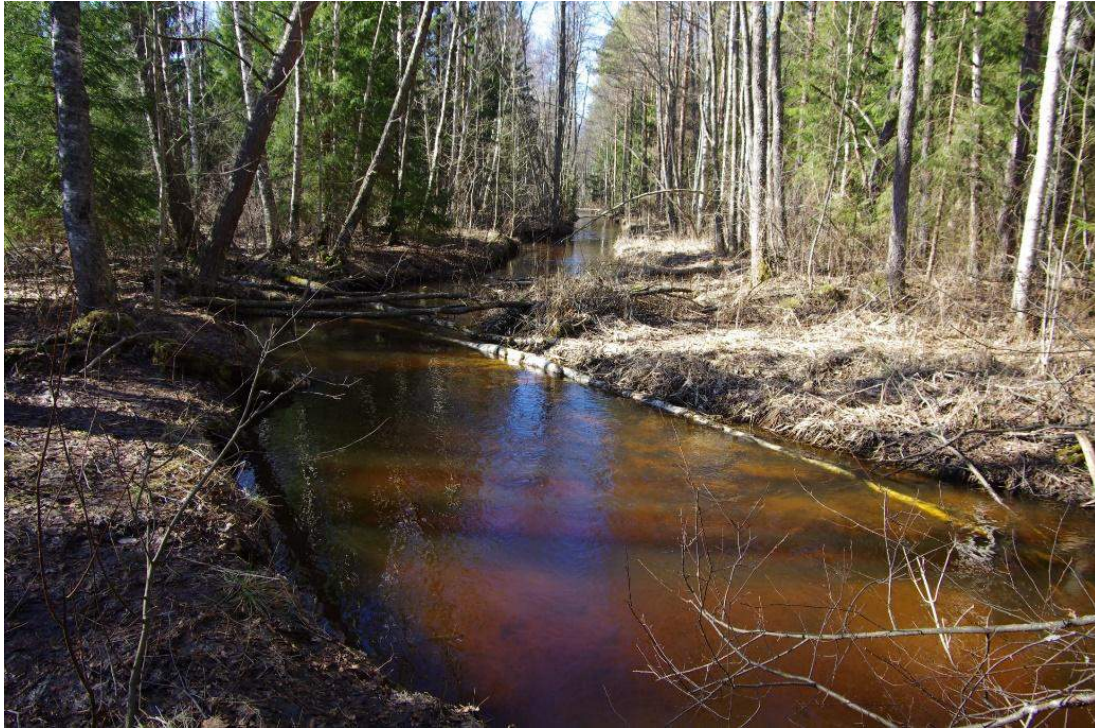
*Kaldamäe stream entering to the project site in eastern margin.*

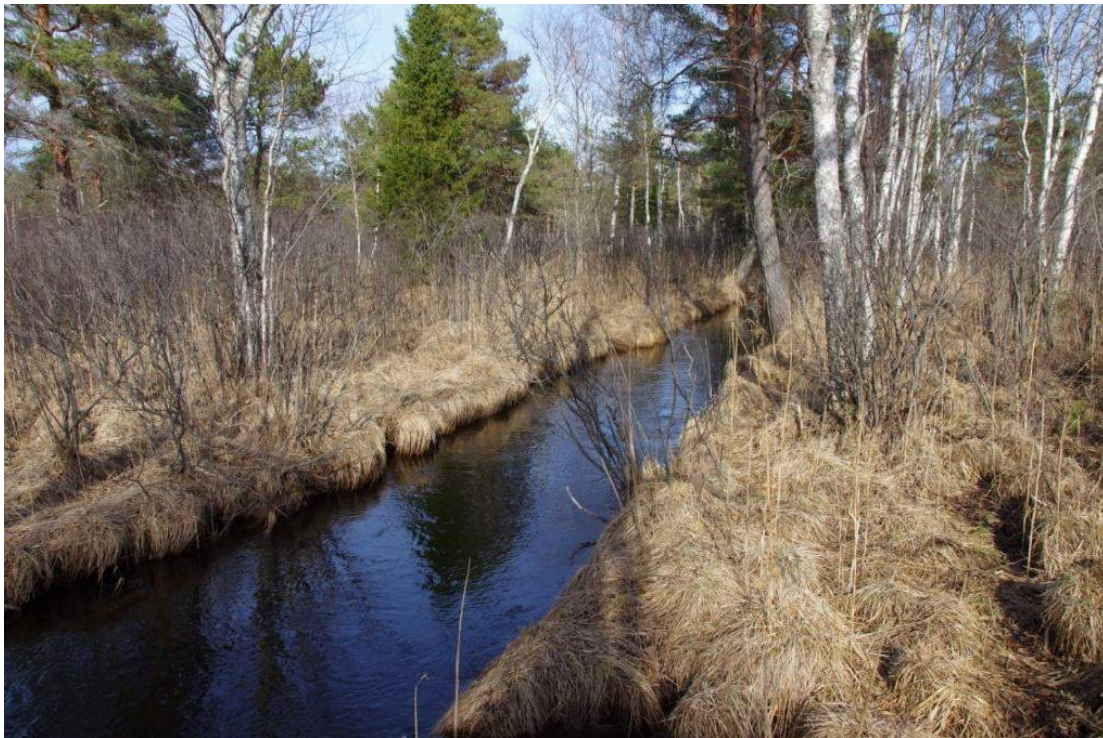
*Pennu stream in the middle of the project site.*

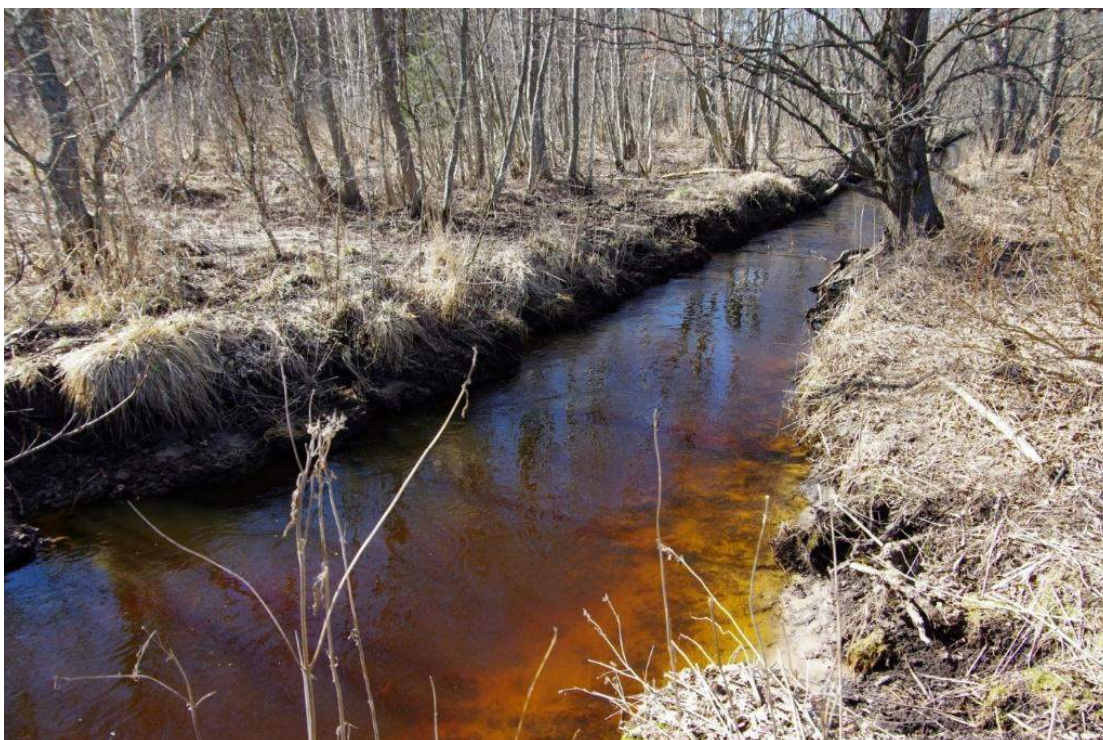
*Piirsalu River in the south-eastern part of the project site.*
